Protecting Home Court

Roof Restoration Project Brings Back Luster to Quicken Loans Arena

QUICKEN LOANS AREA CLEVELAND, OHIO

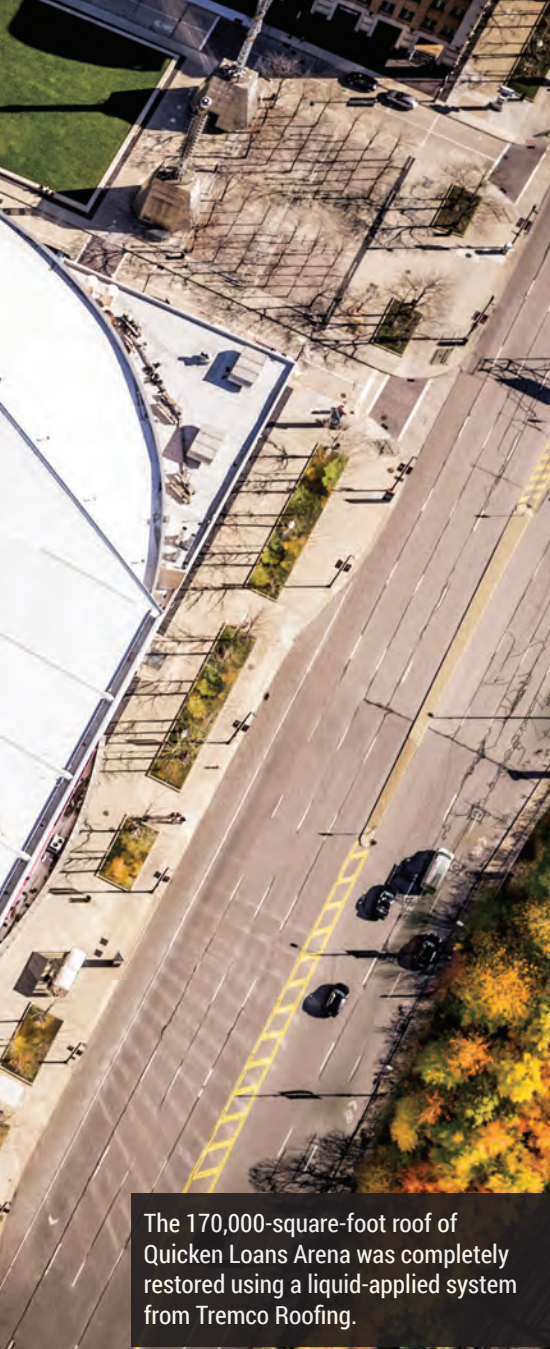
The 170,000-square-foot roof of Quicken Loans Arena was completely restored using a liquid-applied system from Tremco Roofing.

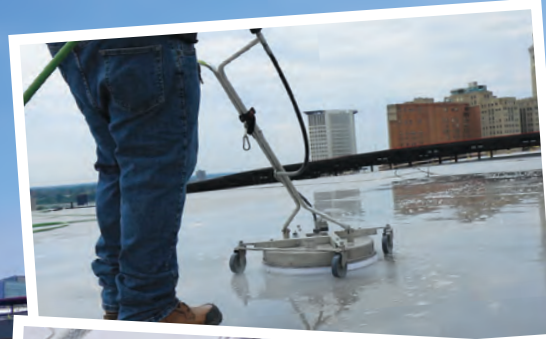
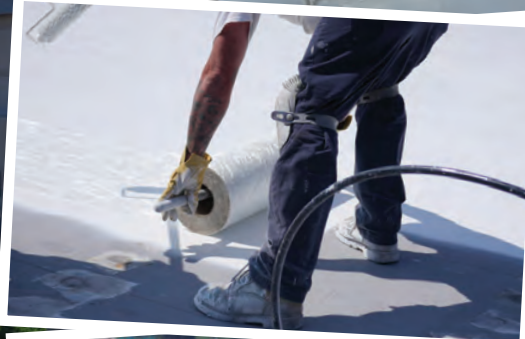
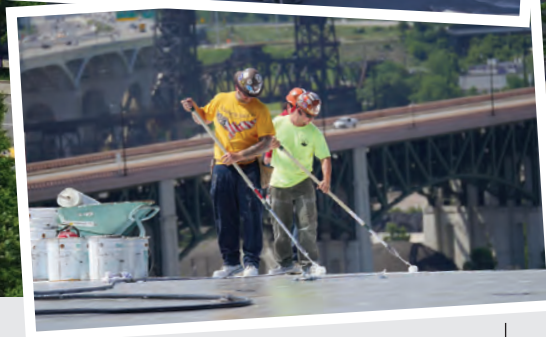
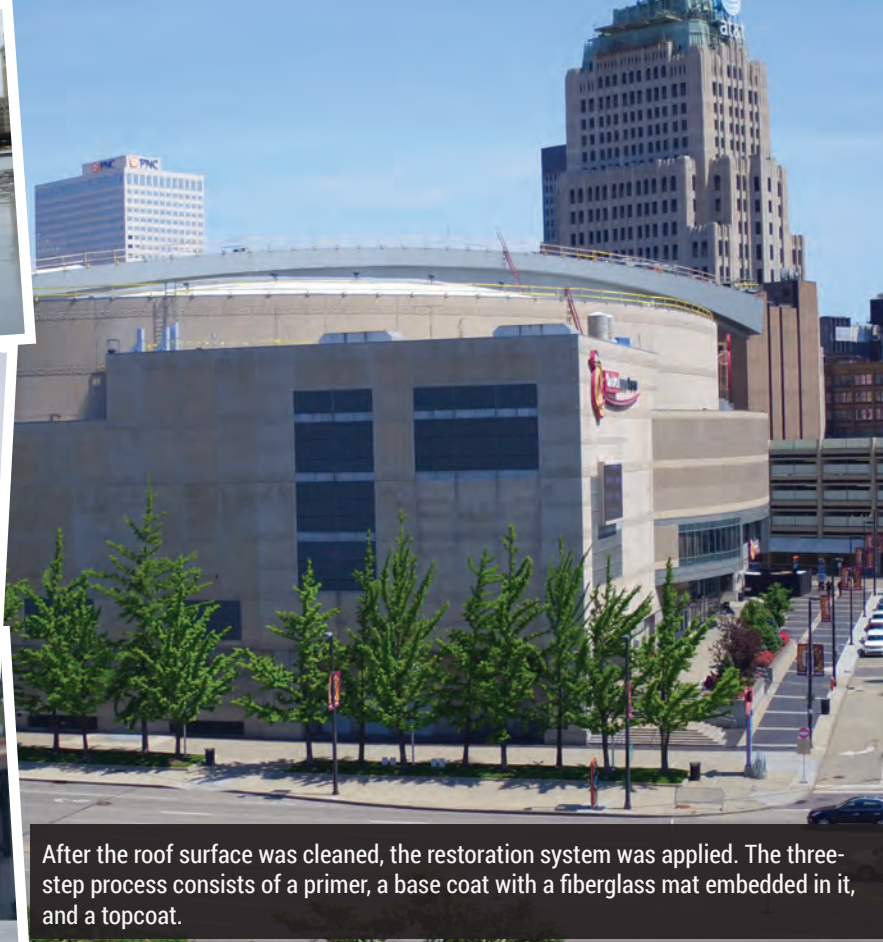
After the roof surface was cleaned, the restoration system was applied. The three-step process consists of a primer, a base coat with a fiberglass mat embedded in it, and a topcoat.

After the sections were cleaned, crews installed the liquid-applied AlphaGuard MT system. The three-step process consists of a primer, a base coat with a fiberglass mat embedded in it, and a topcoat. In this case, the primer was applied with rollers. "The area that we primed each morning was the section we would apply the first coat of AlphaGuard MT with the fiberglass mat that afternoon," Vetrovsky says. "We did not prime ahead. We didn't want to take the chance of dust adhering to the primer."

Care had to be taken with the schedule to complete the work efficiently. “Once the base coat is on, you have 72 hours to apply the top coat,” Vetrovsky explains. “We would install the base coat and the fiberglass mat for two to three days to get a big enough area. The topcoat would go on faster because you’re not embedding any mesh into it. You really had to always keep an eye on the future weather to make sure you could get the topcoat on within the 72 hours.”

The topcoat was applied with both rollers and spray equipment. After the topcoat was applied, crews installed a second coat with sand embedded in it as a wear surface. Because of the roof’s curved surface, walk pads were not feasible, so the sand was used to provide additional traction for any workers conducting ongoing maintenance.
